**FORT SHERIDAN  
ORDNANCE SURVEY (50 - ACRE PARCEL)**

# FINAL TECHNICAL REPORT

**FORMER FORT SHERIDAN  
UNEXPLODED ORDNANCE SURVEY**

**FINAL TECHNICAL REPORT**

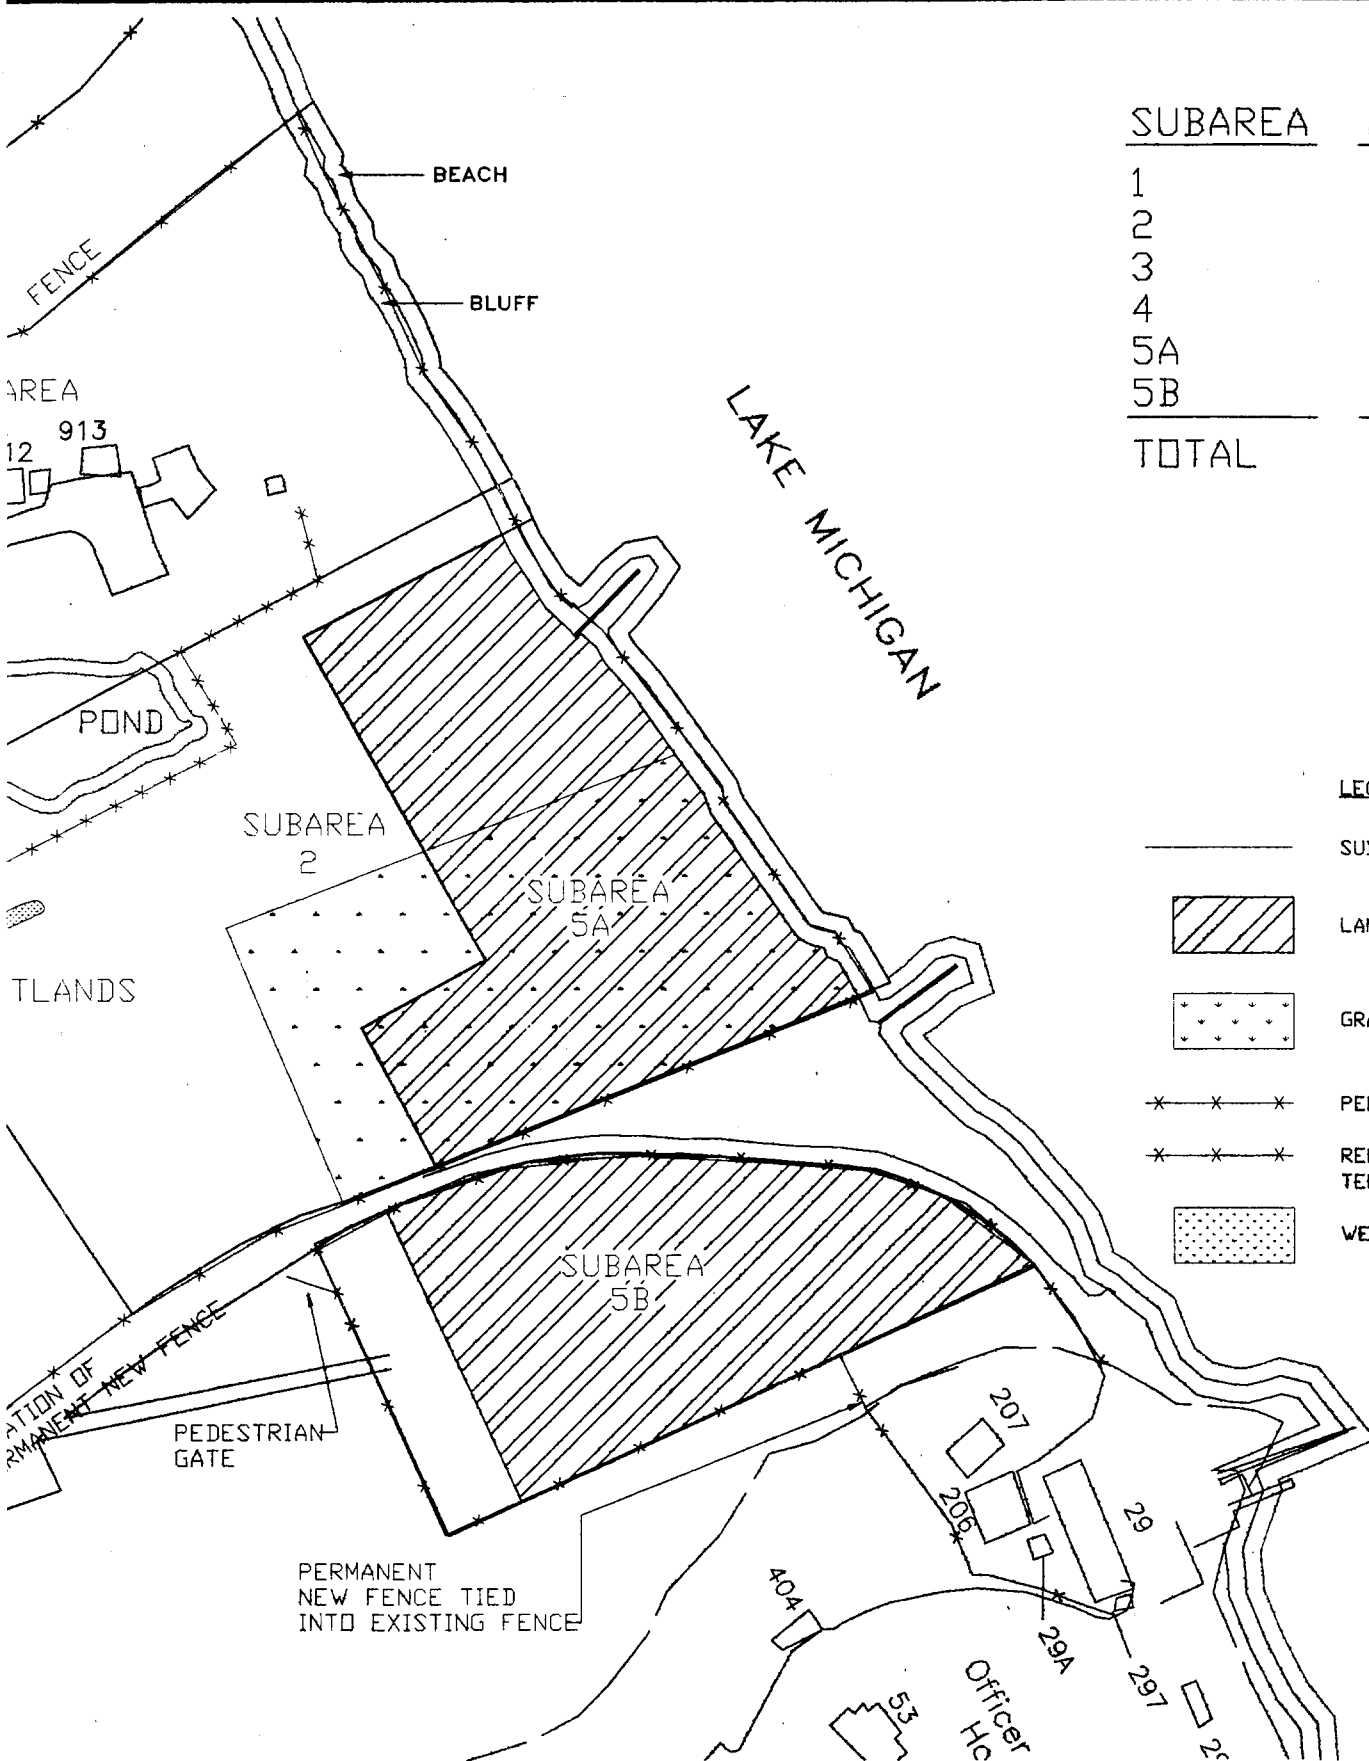
The 50-acre parcel was divided into five subareas of approximately 10-acres. Figure 3 shows the locations of the five subareas. Subarea 5, which covers the boundary of Landfill #2, as determined by the Enhanced Preliminary Assessment, was further divided into subareas 5A and 5B.

The 50-acre survey area was divided into five subareas numbered 1 through 5. Subareas 3 and 4 were further divided into three additional work areas labeled 3A, 3B, 3C, and 4A, 4B, and 4C. Subarea 5 was further divided into 5A and 5B to denote the distinct areas as separated by Nicholson Road.

The identified wetlands were mapped using the technique described in Section 2.1.8 of this report, and are shown in Figure 3. The wetlands delineation memorandum report is included in Appendix A.

The results of the previously-described field activities are documented in this report. Figure 3 shows:

- Project and subarea boundaries
- The location of the temporary fence
- The location of wetlands

SUBAREA	ACREAGE
1	9.4
2	8.3
3	12.5
4	10.5
5A	6.0
5B	4.8
<b>TOTAL</b>	<b>51.5</b>

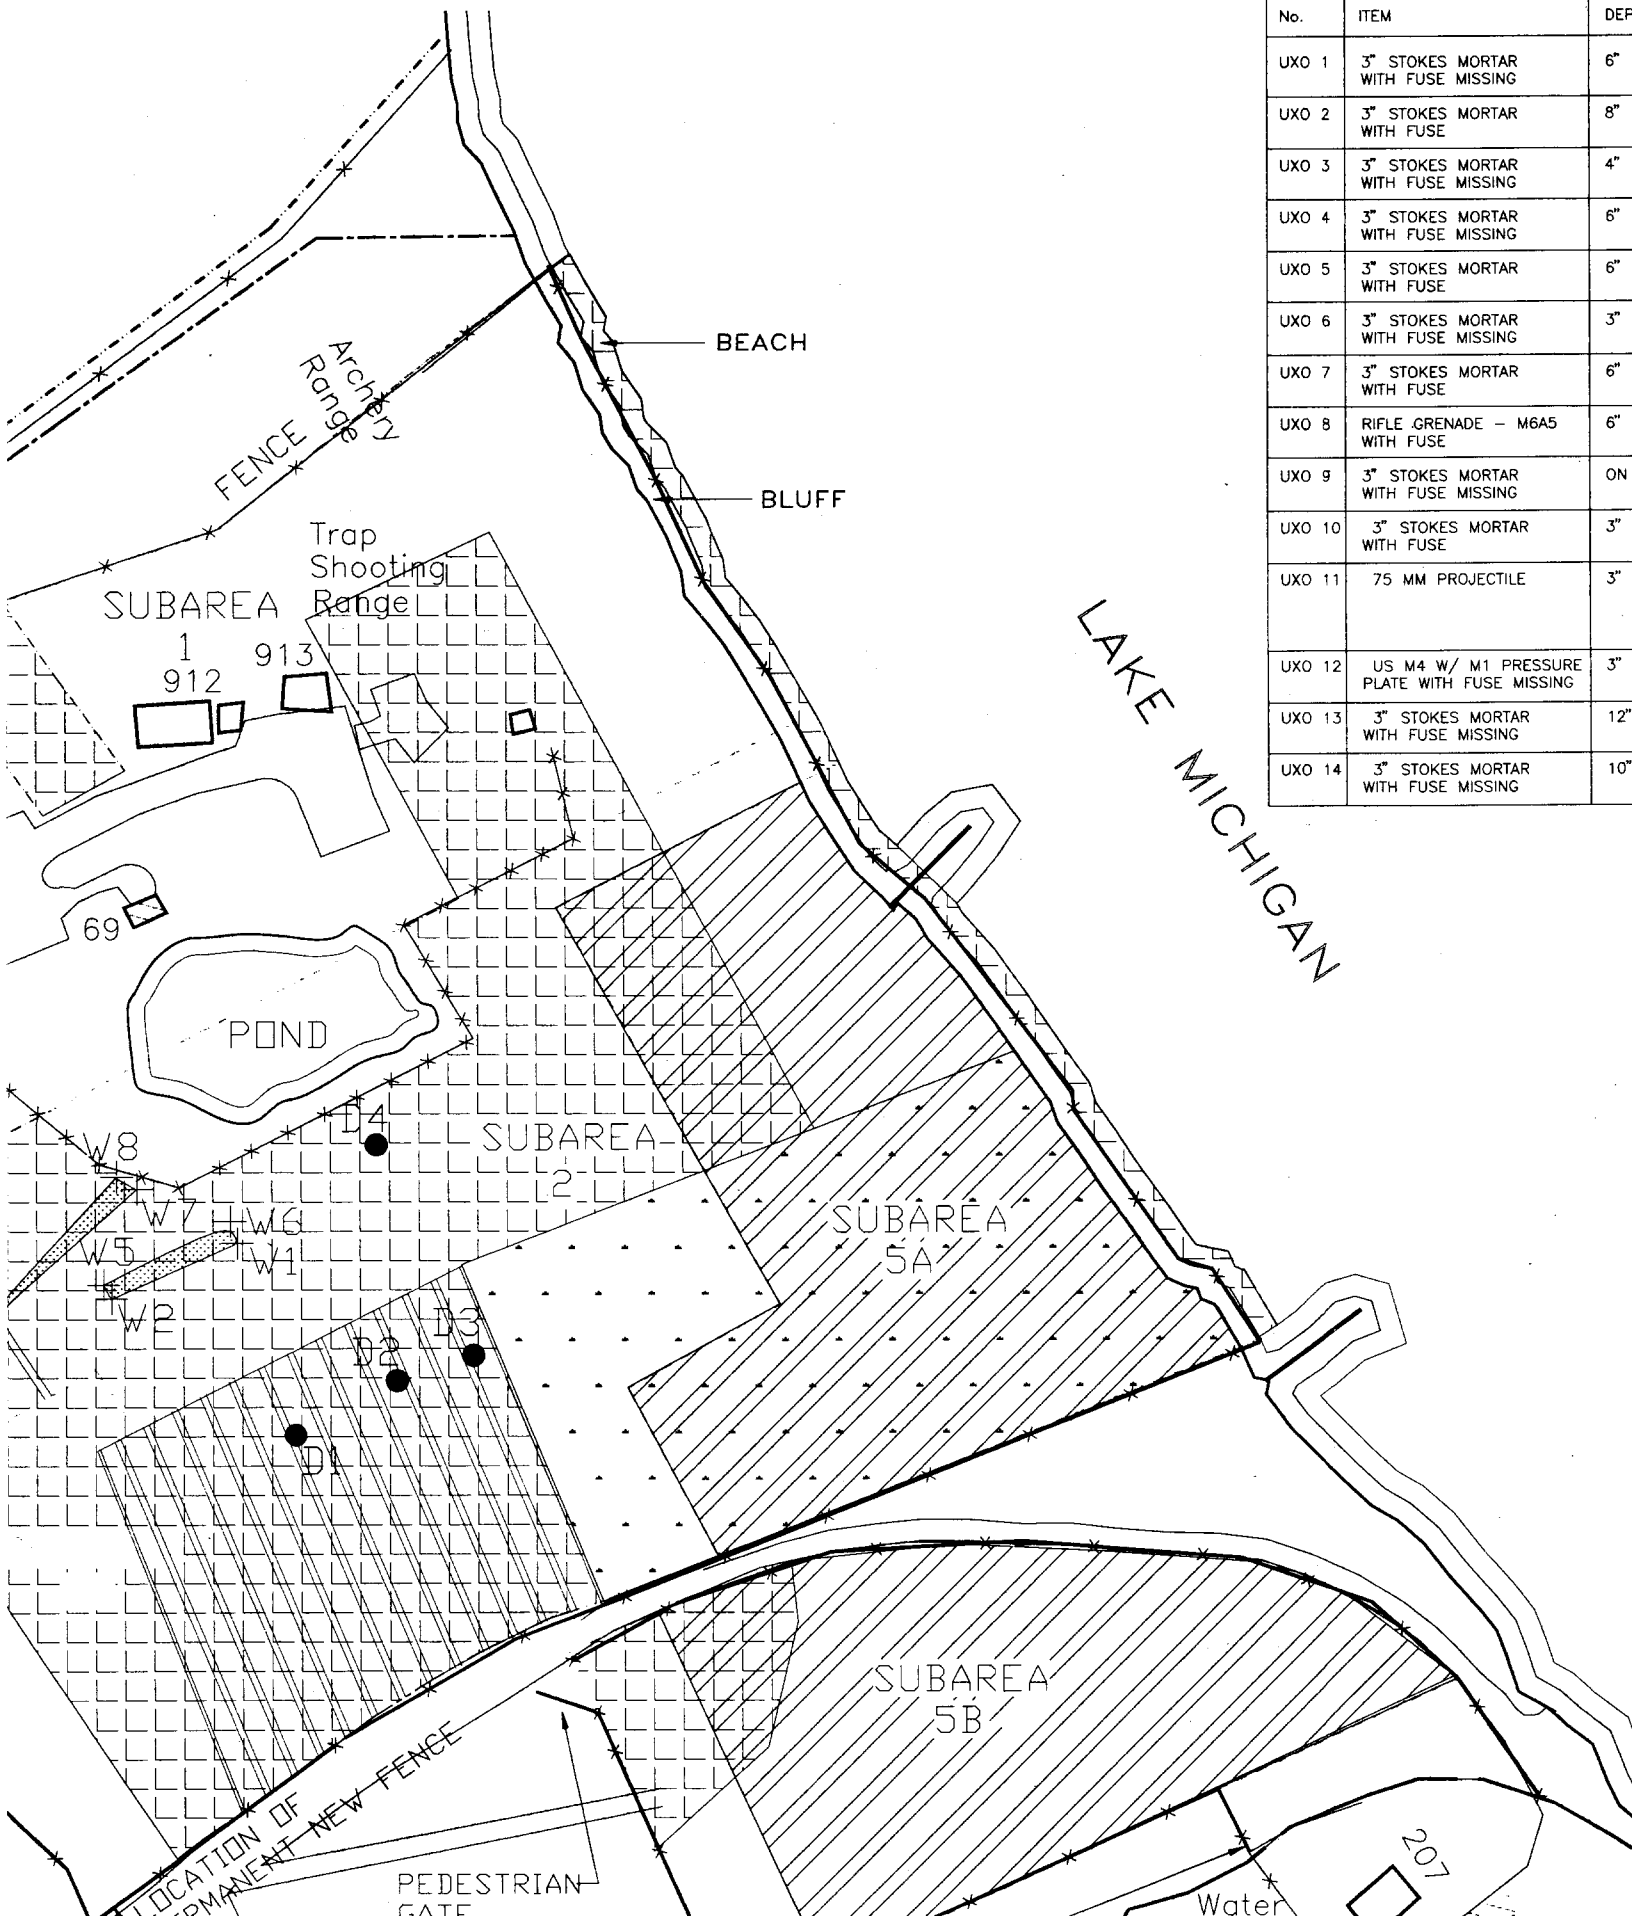
Figure 4 shows:

- The project site boundary
- The location of UXO disposal detonations
- The location of the two seismographs

No.	ITEM	DEF
UXO 1	3" STOKES MORTAR WITH FUSE MISSING	6"
UXO 2	3" STOKES MORTAR WITH FUSE	8"
UXO 3	3" STOKES MORTAR WITH FUSE MISSING	4"
UXO 4	3" STOKES MORTAR WITH FUSE MISSING	6"
UXO 5	3" STOKES MORTAR WITH FUSE	6"
UXO 6	3" STOKES MORTAR WITH FUSE MISSING	3"
UXO 7	3" STOKES MORTAR WITH FUSE	6"
UXO 8	RIFLE GRENADE - M6A5 WITH FUSE	6"
UXO 9	3" STOKES MORTAR WITH FUSE MISSING	ON
UXO 10	3" STOKES MORTAR WITH FUSE	3"
UXO 11	75 MM PROJECTILE	3"
UXO 12	US M4 W/ M1 PRESSURE PLATE WITH FUSE MISSING	3"
UXO 13	3" STOKES MORTAR WITH FUSE MISSING	12"
UXO 14	3" STOKES MORTAR WITH FUSE MISSING	10"

No.	ITEM	DEPTH FOUND AT	DETONATION SITE	STATE PLANAR COORDINATES NAD 83		LATITUDE	LONGITUDE
				(X) EASTING	(Y) NORTHING		
UXO 1	3" STOKES MORTAR WITH FUSE MISSING	6"	D1	1420739.2859	15337792.1894	78° 35' 24.84"	082° 18' 03.47"
UXO 2	3" STOKES MORTAR WITH FUSE	8"	D1	1420644.5792	15337741.4395	78° 35' 24.44"	082° 18' 08.40"
UXO 3	3" STOKES MORTAR WITH FUSE MISSING	4"	D1	1420627.1332	15337872.9751	78° 35' 25.74"	082° 18' 08.59"
UXO 4	3" STOKES MORTAR WITH FUSE MISSING	6"	D1	1420702.7324	15337911.8143	78° 35' 26.04"	082° 18' 04.66"
UXO 5	3" STOKES MORTAR WITH FUSE	6"	D1	1420837.3157	15337941.3321	78° 35' 26.20"	082° 17' 57.86"
UXO 6	3" STOKES MORTAR WITH FUSE MISSING	3"	D4	1420720.1784	15338013.3142	78° 35' 27.02"	082° 18' 03.28"
UXO 7	3" STOKES MORTAR WITH FUSE	6"	D4	1420668.6713	15337986.3857	78° 35' 26.81"	082° 18' 05.96"
UXO 8	RIFLE GRENADE - M6A5 WITH FUSE	6"	D4	1420810.7313	15337816.0108	78° 35' 25.00"	082° 17' 59.81"

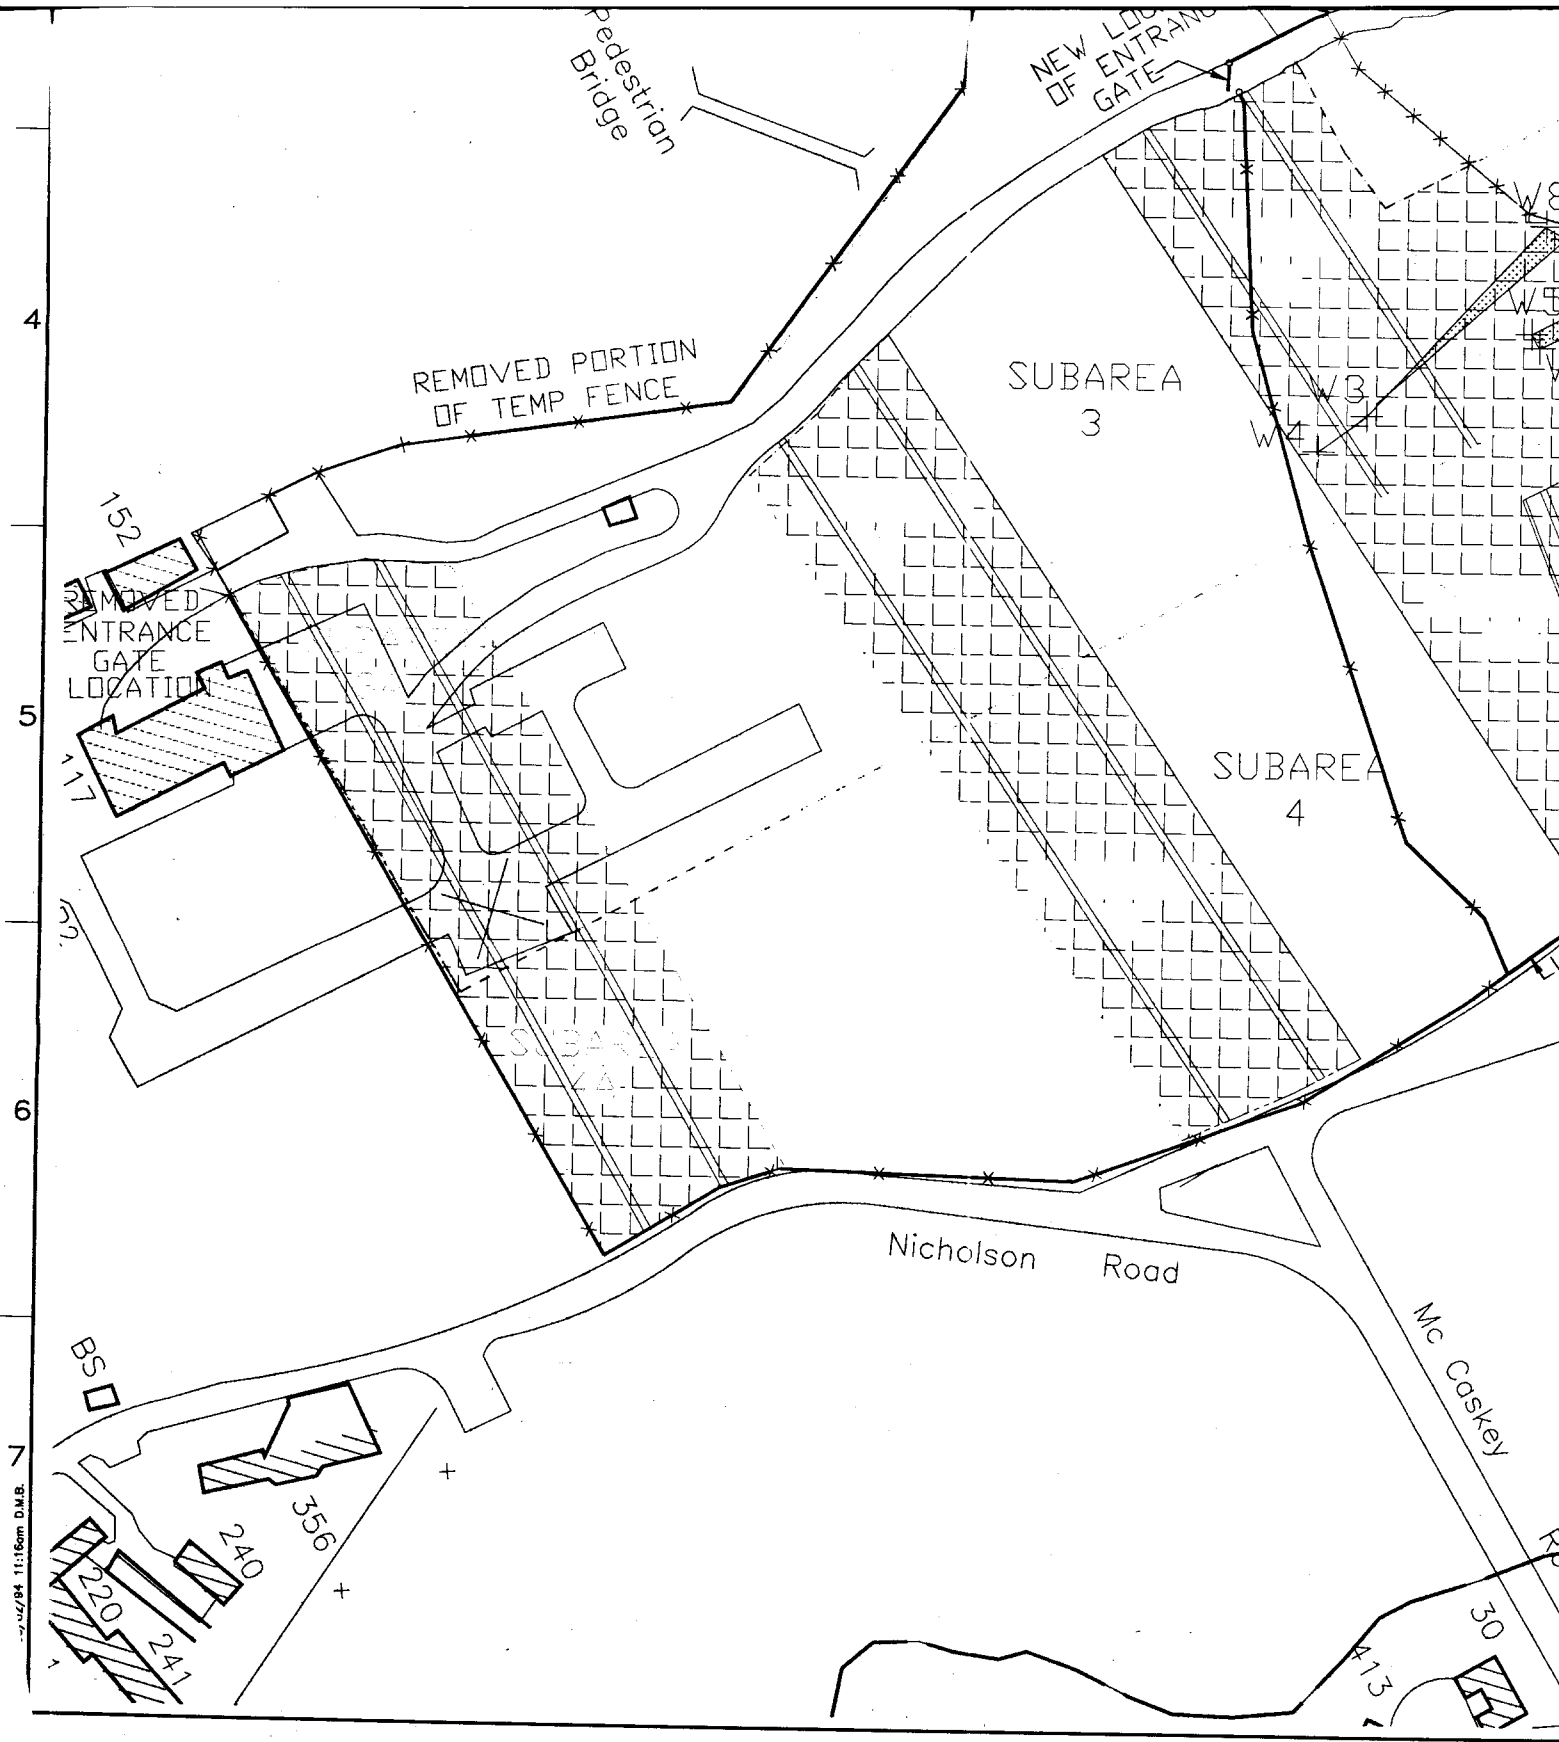
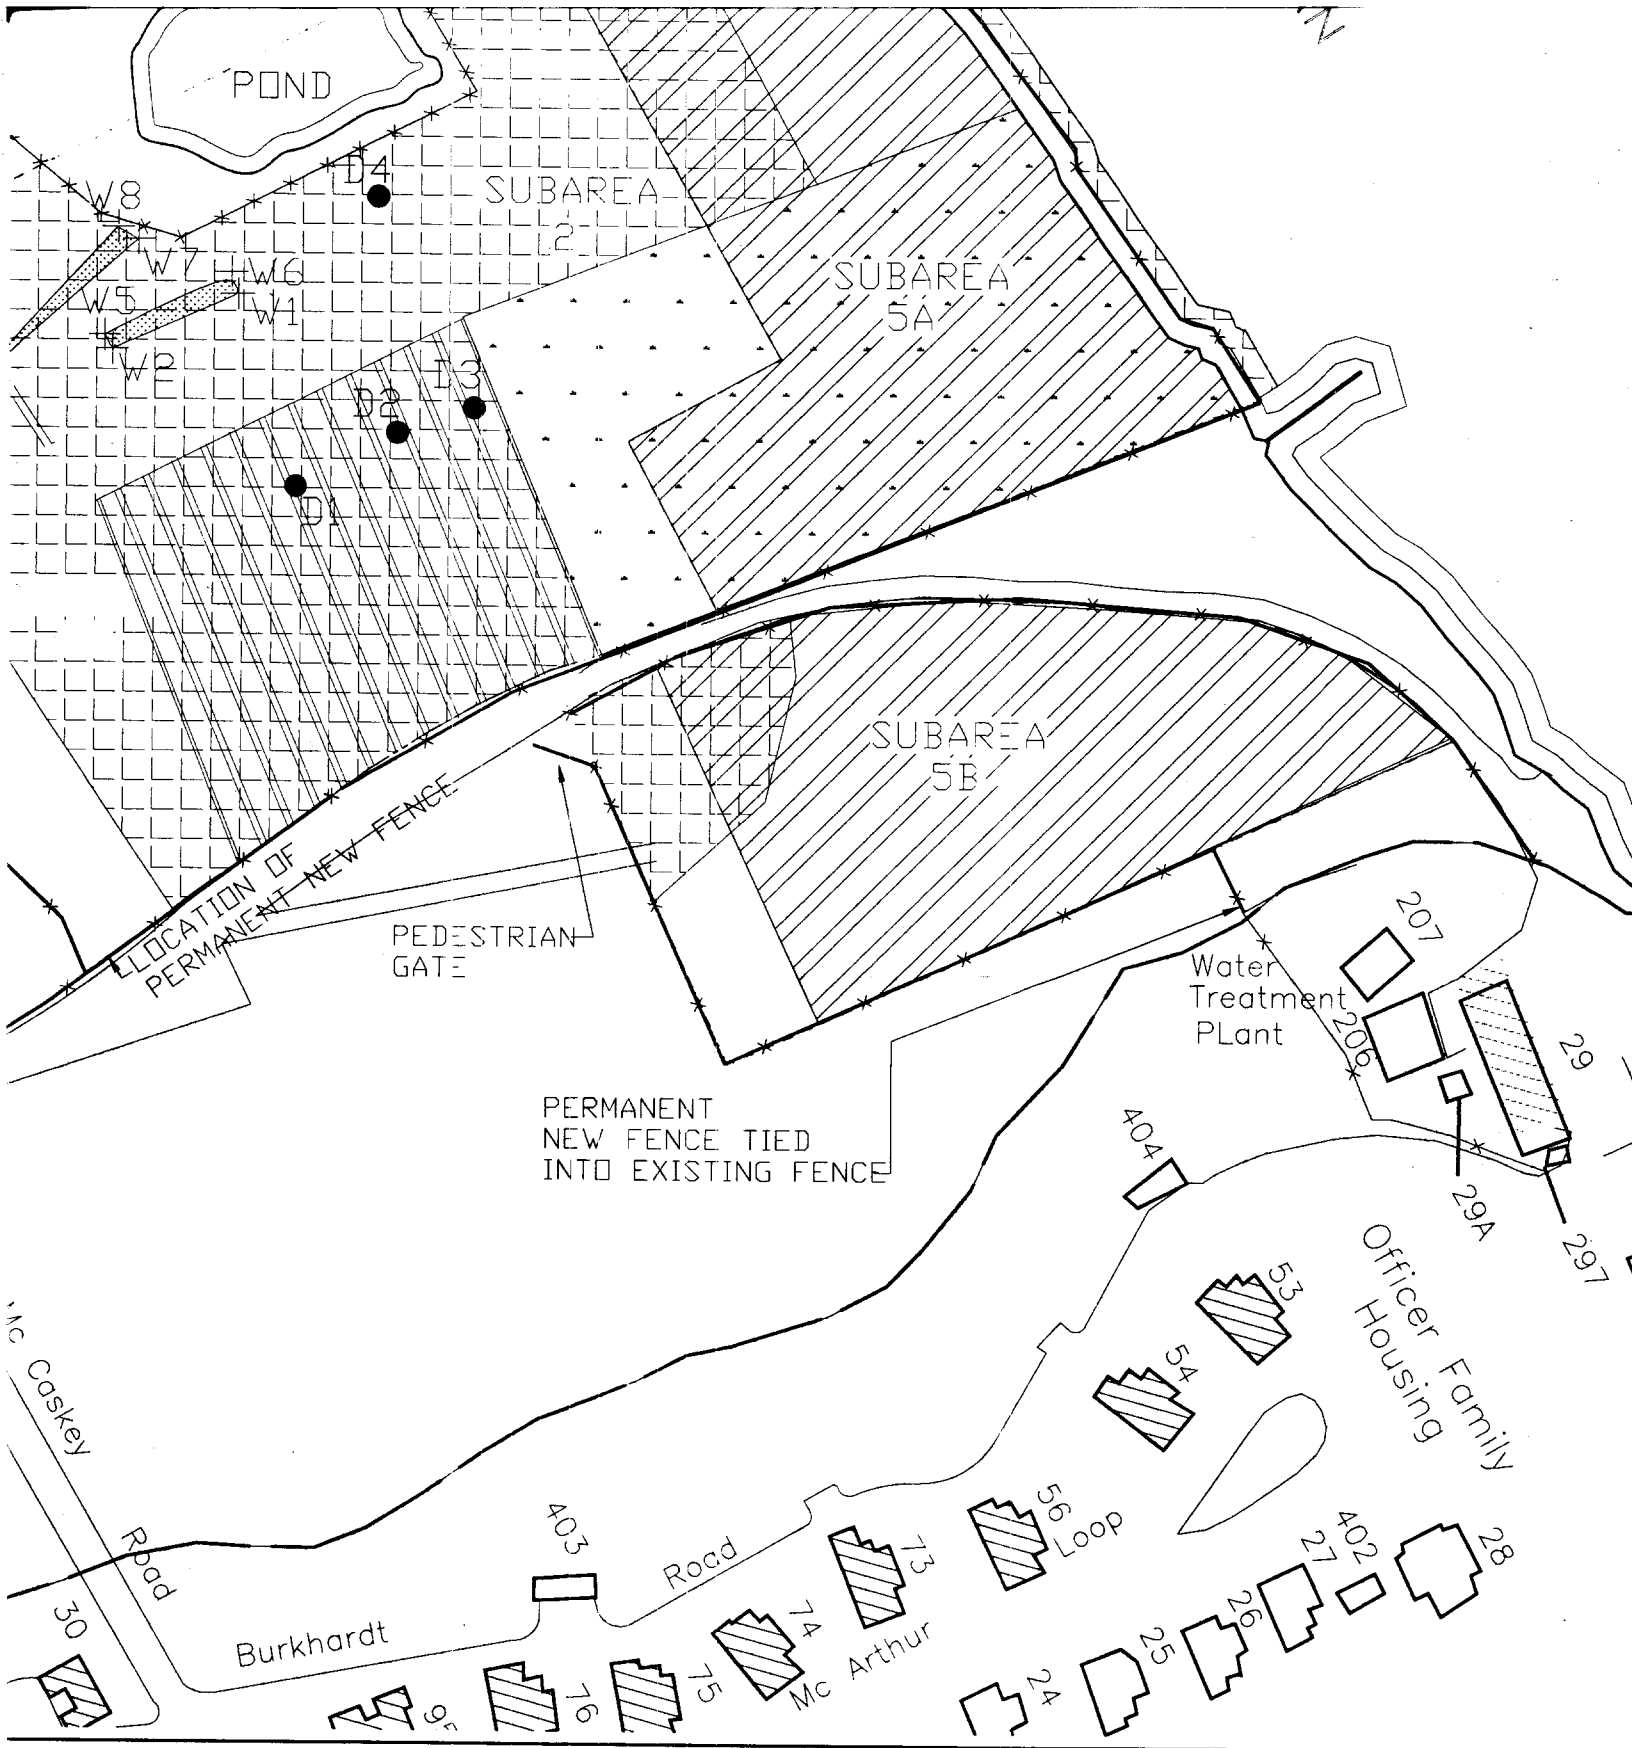
With the exception of paved areas and buildings, the designated survey areas, as shown in Figure 5, were surveyed for surface metallic objects. Schonstedt low-sensitivity magnetometers were

Figure 5 shows:

- The project site boundary
- The temporary fence location
- Subarea boundaries
- Surface UXO survey areas completed
- The location of UXO disposal detonations

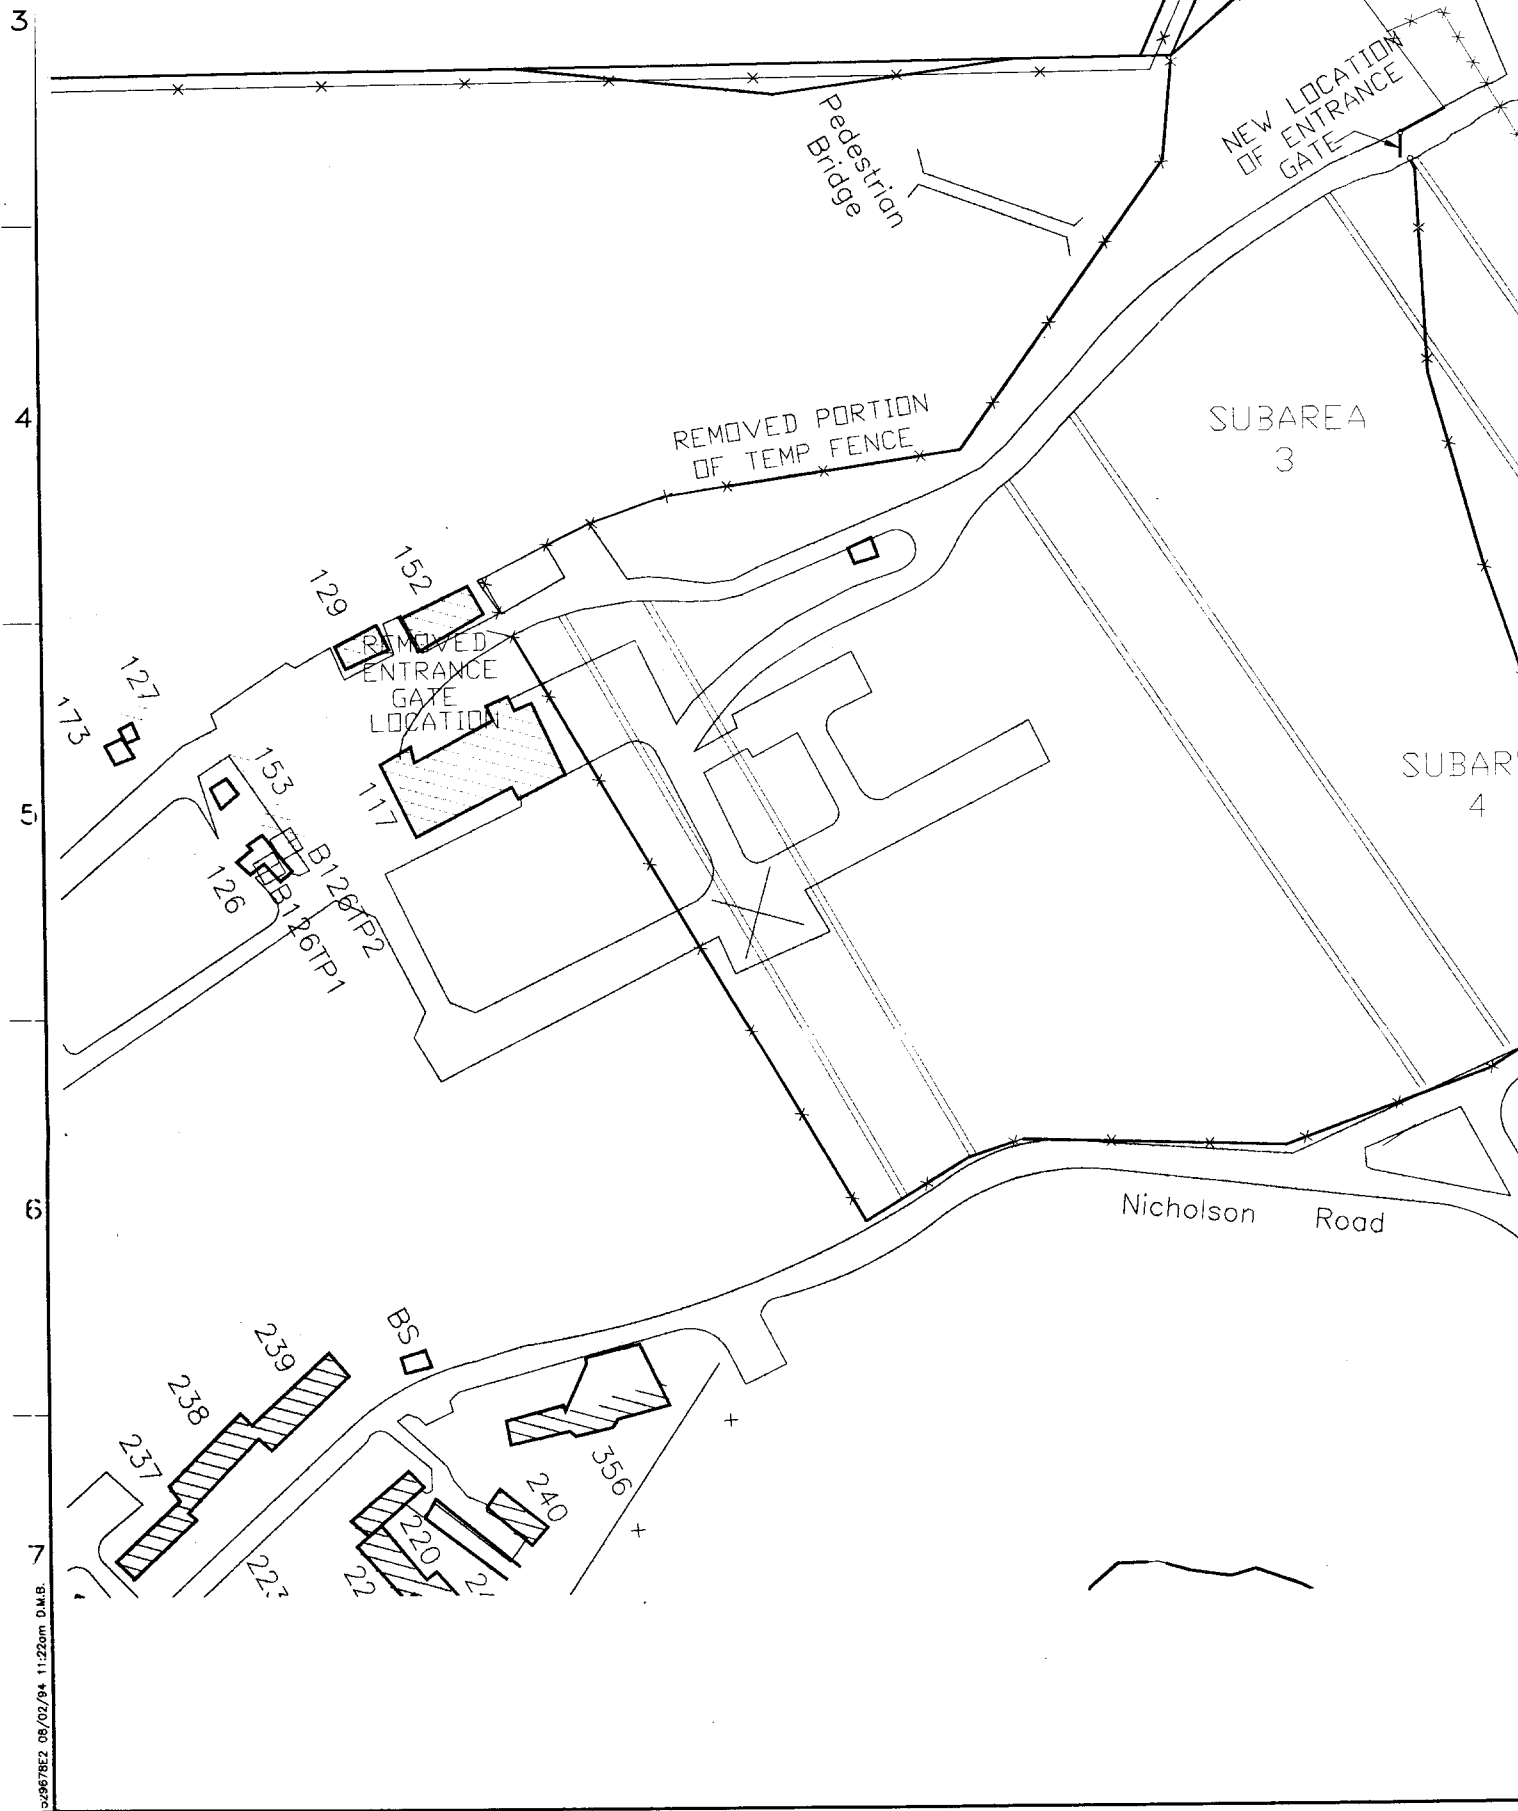
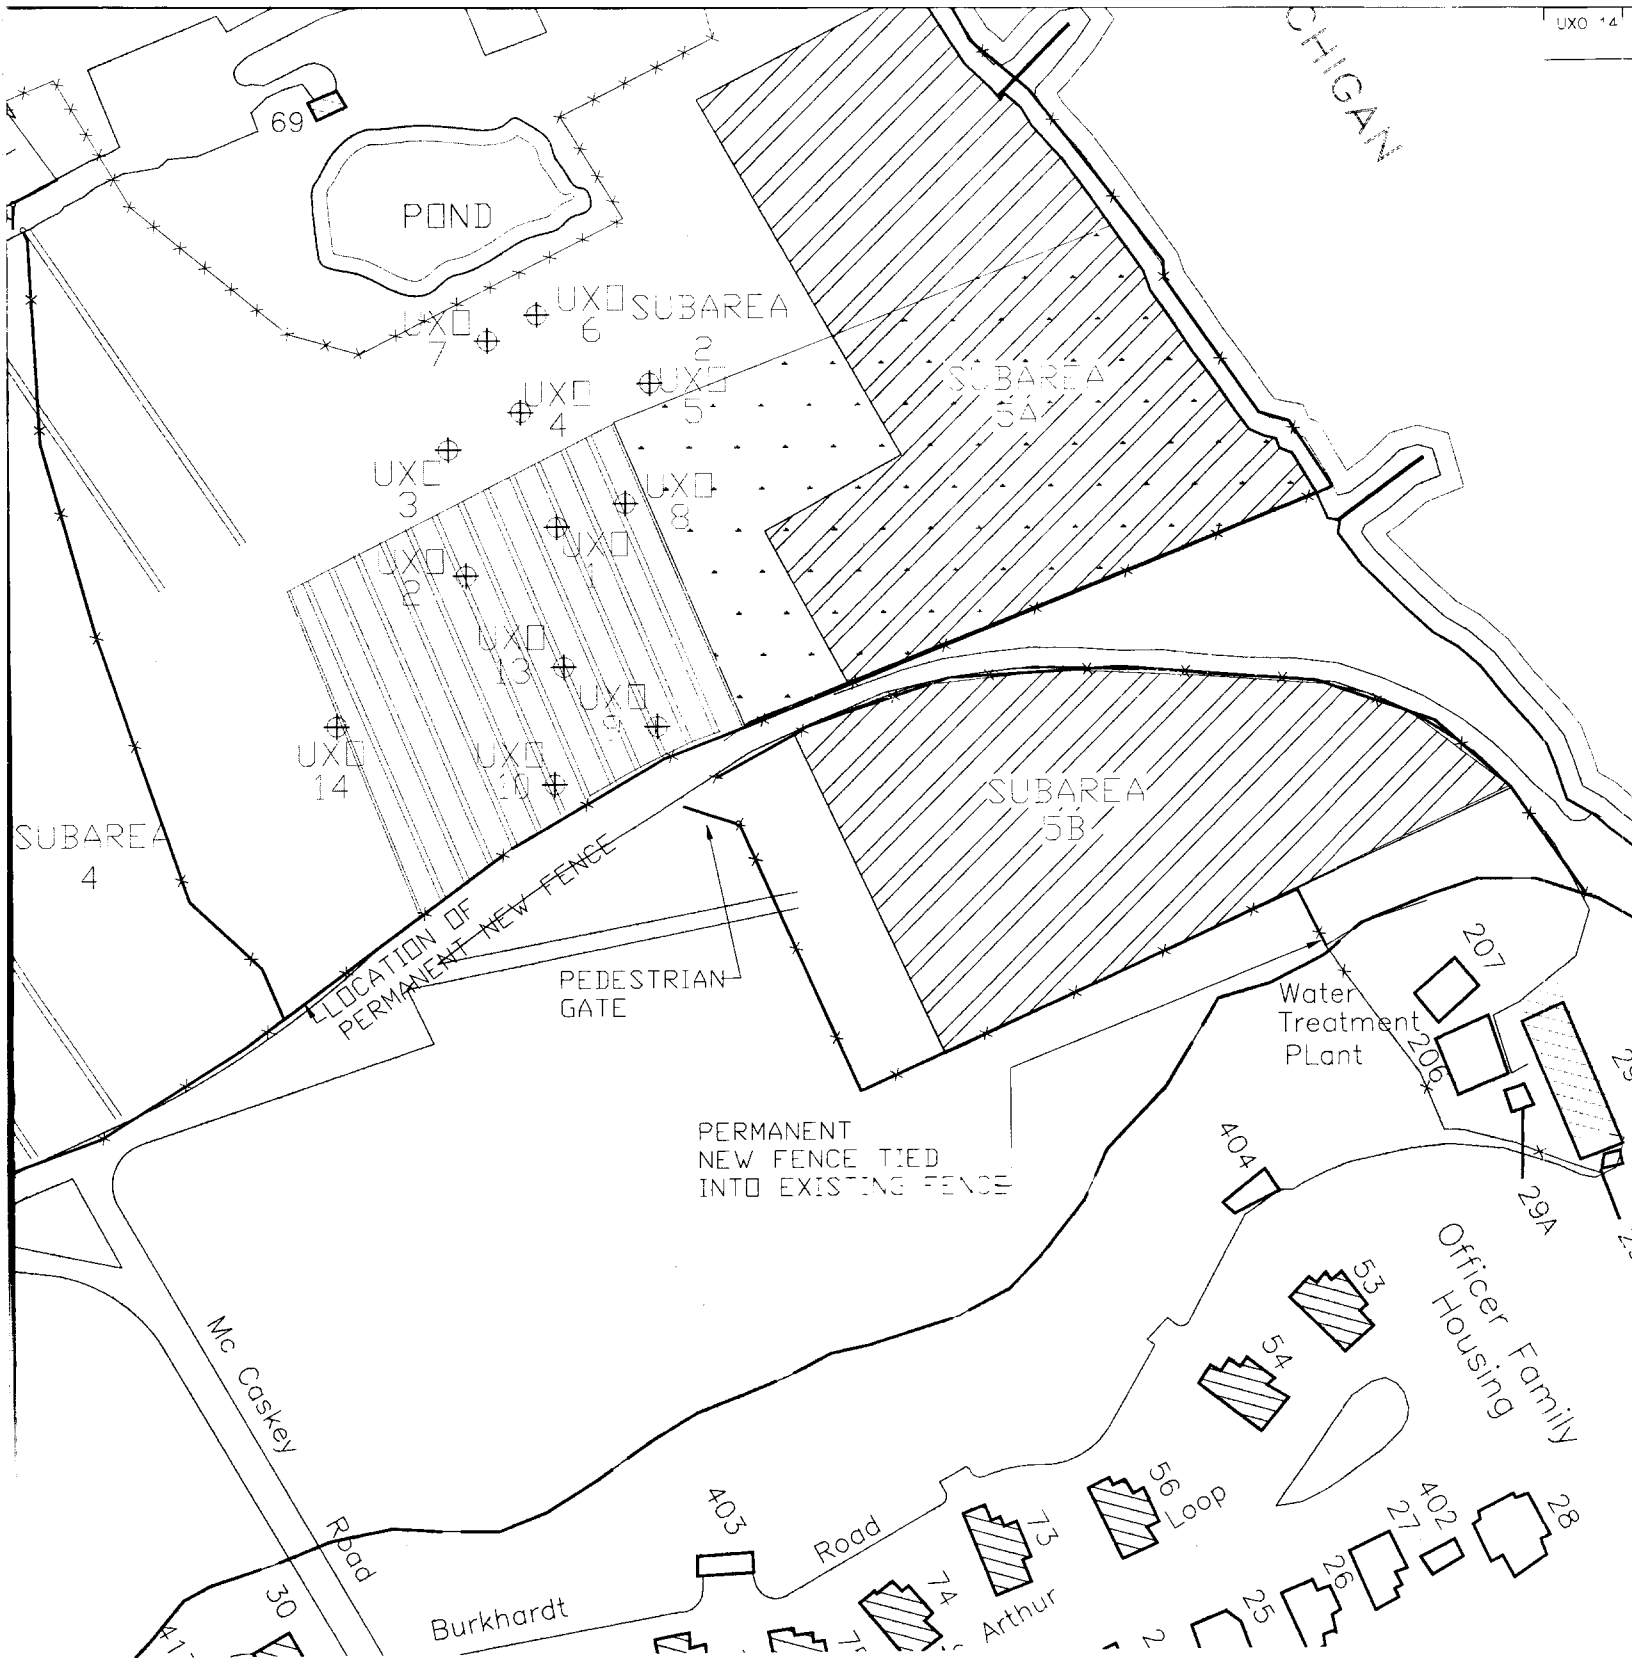
The subsurface survey was conducted, in the specific locations identified in Figure 6, within one-meter-wide subsurface survey lanes. The established lanes were surveyed with a Foerster Ferex high-sensitivity magnetometer and all detected items were marked with a pin flag, as previously described, for subsequent excavation.

Each UXO found was entered into the project UXO accountability system. Each UXO was assigned a sequential identification number, and all data pertaining to the UXO was recorded on a UXO Accountability Log sheet. The UXO Accountability Log was used to track all movement of the UXO until final disposal of the UXO by military EOD. Appendix B lists all UXO found during the project by sequential accountability number. The UXO Accountability Log sheets are included as Appendix C. The location of each UXO found is documented in Figure 6.

Figure 6 shows:

- The project site boundary
- The temporary fence location
- Subarea boundaries
- Subsurface UXO survey areas completed
- The location, identification, and depth for 14 UXO detected during the project
- The location of UXO

No.	ITEM	DEPTH FOUND AT
UXO 1	3" STOKES MORTAR WITH FUSE MISSING	6"
UXO 2	3" STOKES MORTAR WITH FUSE	8"
UXO 3	3" STOKES MORTAR WITH FUSE MISSING	4"
UXO 4	3" STOKES MORTAR WITH FUSE MISSING	6"
UXO 5	3" STOKES MORTAR WITH FUSE	6"
UXO 6	3" STOKES MORTAR WITH FUSE MISSING	3"
UXO 7	3" STOKES MORTAR WITH FUSE	6"
UXO 8	RIFLE GRENADE - M6A5 WITH FUSE	6"
UXO 9	3" STOKES MORTAR WITH FUSE MISSING	ON SURFACE
UXO 10	3" STOKES MORTAR WITH FUSE	3"
UXO 11	75 MM PROJECTILE	3"
UXO 12	US M4 W/ M1 PRESSURE PLATE WITH FUSE MISSING	3"
UXO 13	3" STOKES MORTAR WITH FUSE MISSING	12"
UXO 14	3" STOKES MORTAR WITH FUSE MISSING	10"
